## MORTARS

### Historic mortars and restoration mortars

Materials and conservation of built cultural heritage – mortars 1

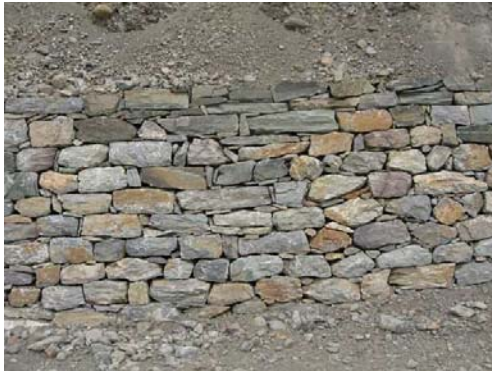
Dry-stone wall; Wanla, Ladakh, India

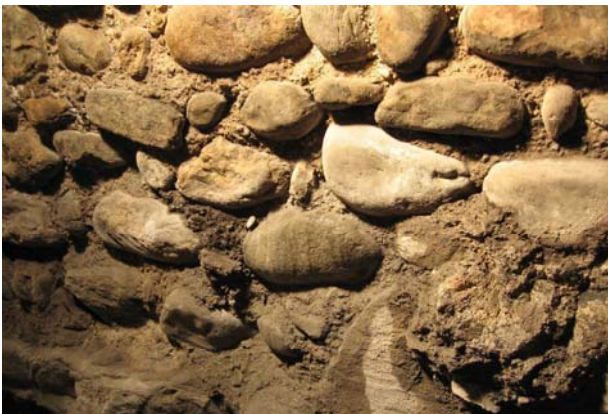
Boulder masonry, around 450 AD,  
St. Stephan, Chur, GR

ca. 30 cm

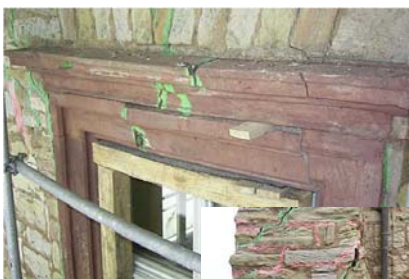
Damage after portland cement injection in Schloss Wiehe (D)

Gypsum/sulfates present outside the cement reacts with C3A to ettringite → enormous volume increase, structural problems

→ soluble salts causing serious deteriorations of historic buildings

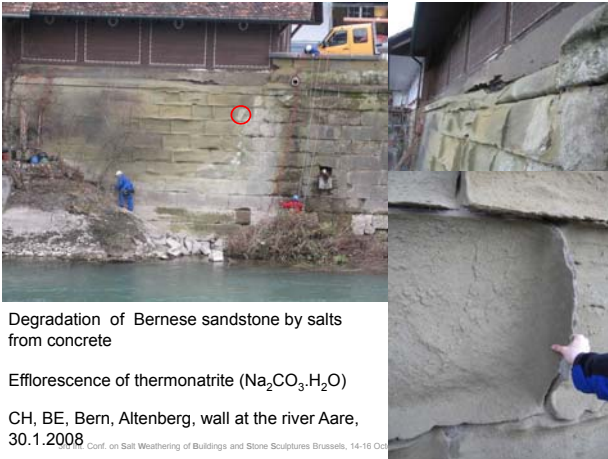
Degradation of Bernese sandstone by salts from concrete

Efflorescence of thermonatrite ( $\text{Na}_2\text{CO}_3 \cdot \text{H}_2\text{O}$ )

CH, BE, Bern, Altenberg, wall at the river Aare, 30.1.2008

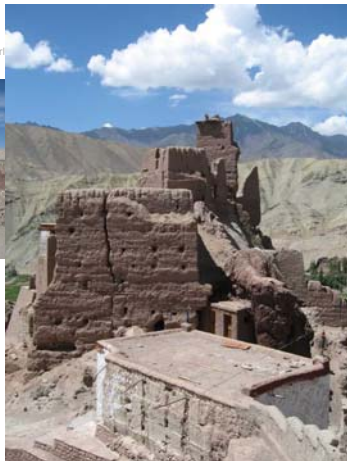
Basgo, Ladakh castle built out of rammed earth (pisé)

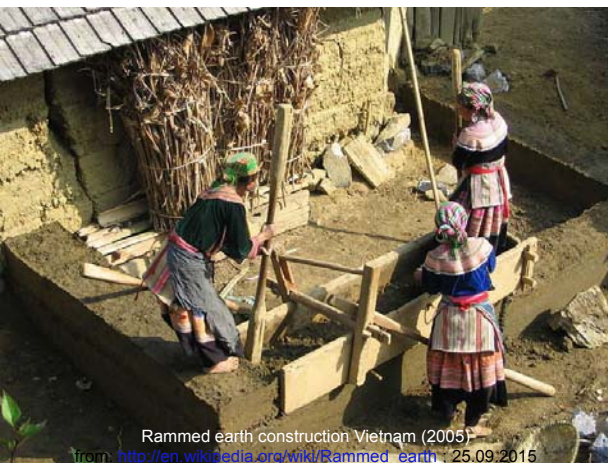
Rammed earth construction Vietnam (2005)  
from [http://en.wikipedia.org/wiki/Rammed\\_earth](http://en.wikipedia.org/wiki/Rammed_earth) ; 25.09.2015

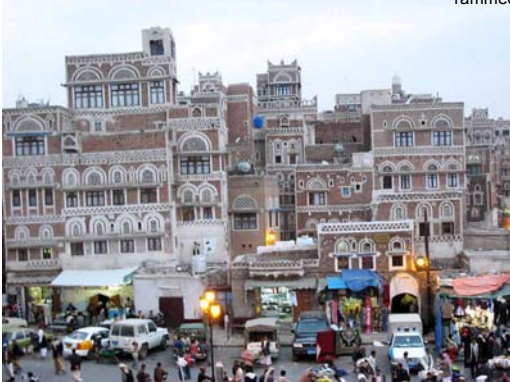
Yemen, Sana'a  
many-storeyed tower-houses built of  
rammed earth (pisé)

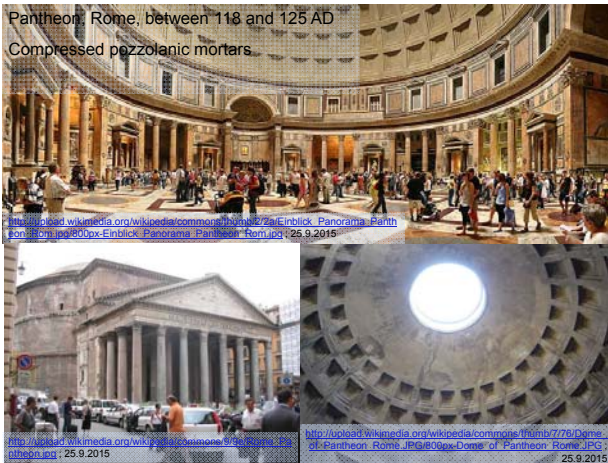
Pantheon, Rome, between 118 and 125 AD  
Compressed pozzolanic mortars

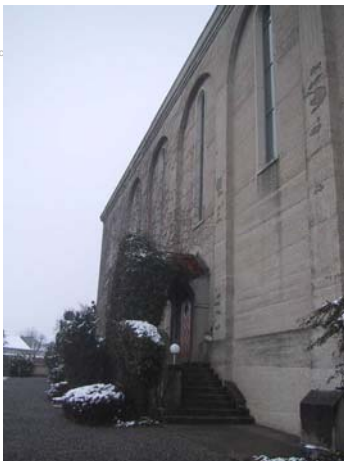
Wuennewil, FR, church  
Rammed concrete ca. 1932 (béton non armé)

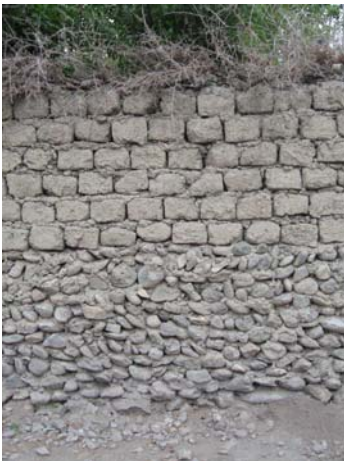
Mixed pebble and mud and mud brick wall

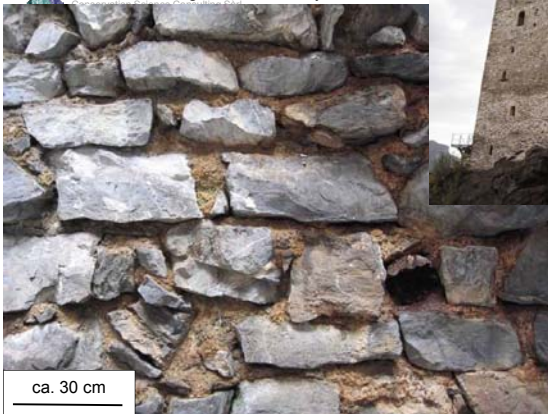
Meiringen, BE, Resti, 14.10.08,  
Rough stone masonry

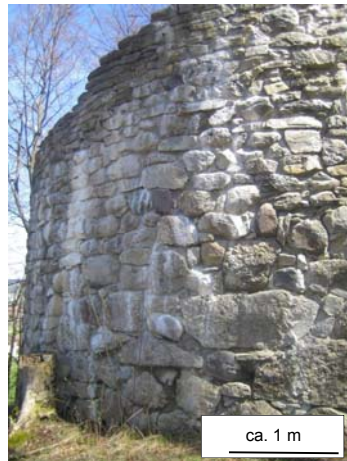
Boulder masonry,  
Bossonens, FR

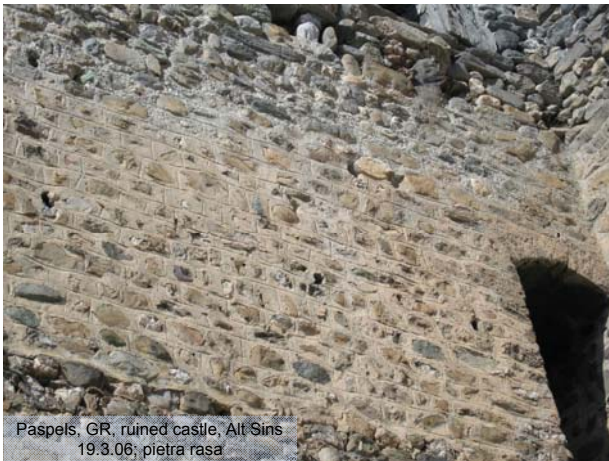
Brienzen, GR, ruined castle Belfort, 13<sup>th</sup> century render on the west wall of the „Palas“

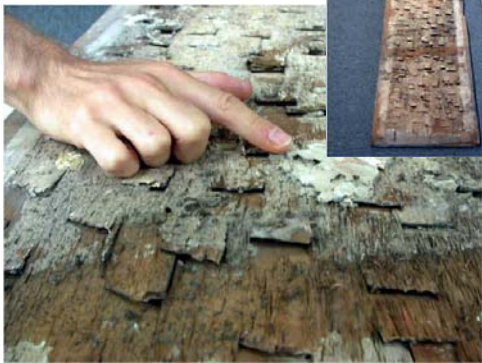
Haus zum Vergnügen Basel  
Wall board, cut with an axe 15.Jh  
Photos Andreas Künig

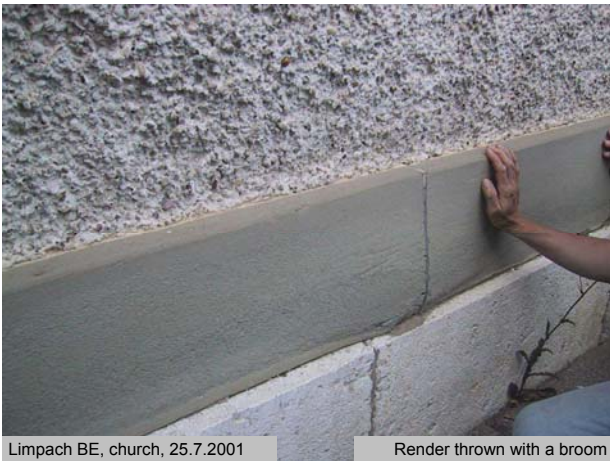
Limpach BE, church, 25.7.2001

Render thrown with a broom

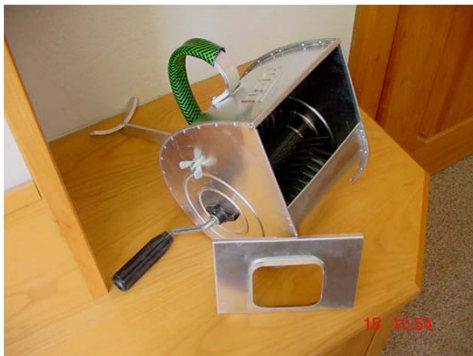
Machine to  
apply a  
„Worms“  
render

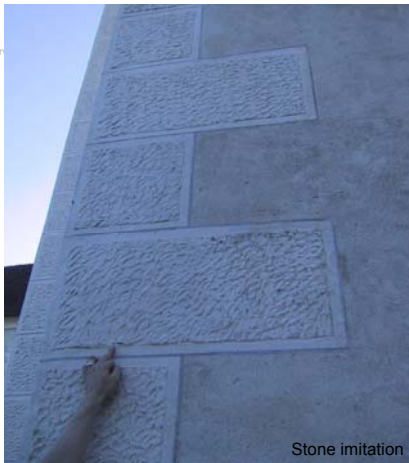
Ittingen TG, Chartreuse, church  
4.5.2003

Stone imitation

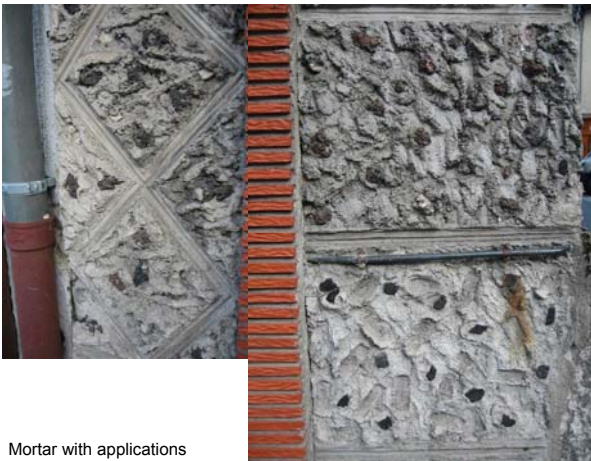
Mortar with applications

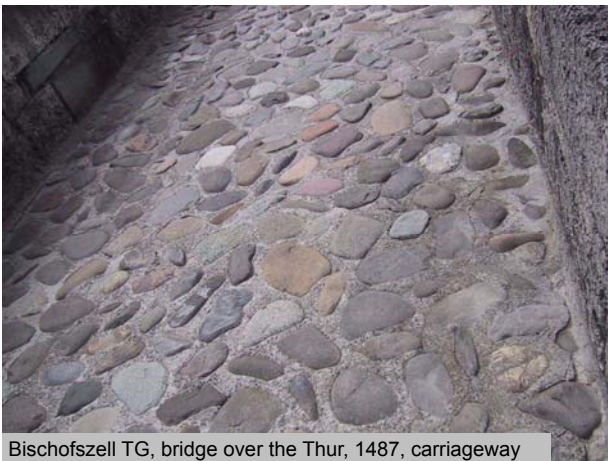
Bischofszell TG, bridge over the Thur, 1487, carriageway

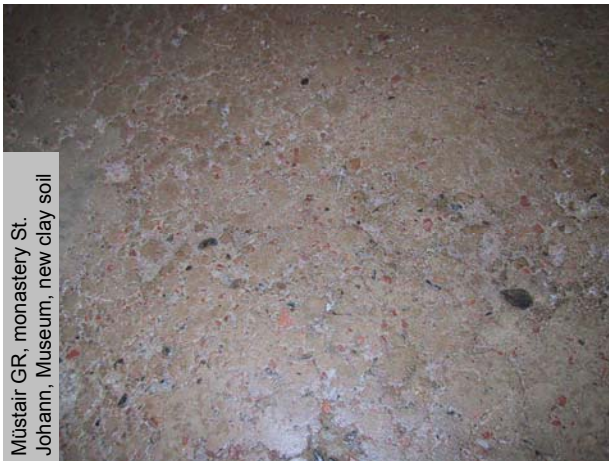
Müstair GR, monastery St. Johann, Museum, new clay soil

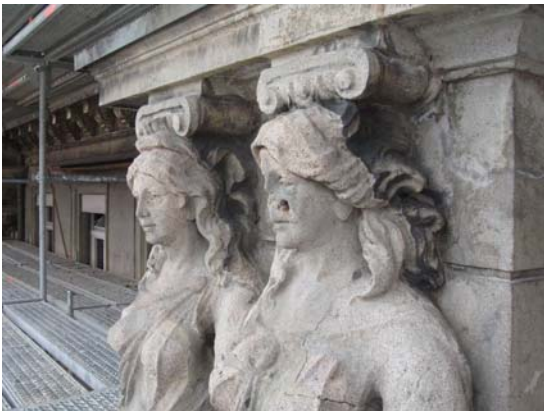
Luzern, former Hotel Beaurivage; stone casts dating from ca. 1910

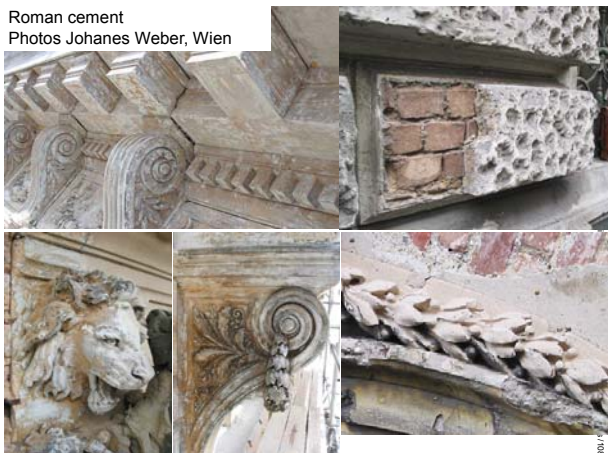
Roman cement  
Photos Johannes Weber, Wien

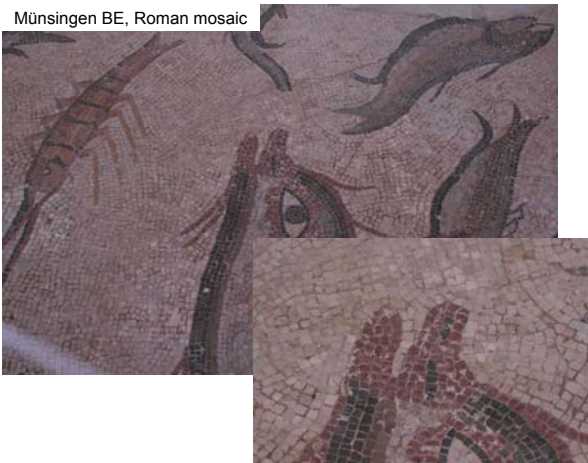
Münsingen BE, Roman mosaic
