## WEATHERING OF NATURAL BUILDING STONES

Materials and conservation of built cultural heritage – The weathering of the natural building stones – BR 1

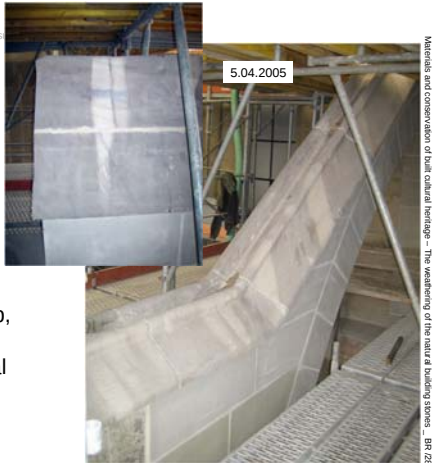
### Discolouration

A flying buttress top, south façade, Lausanne cathedral Arvel Limestone

- The original colour of a material changes because of processes like:
  - water penetration (more or less permanent coloured stains);
  - exposure to sunlight (fading);
  - formation of metallic oxide in the structure; ...but not because of a deposit.

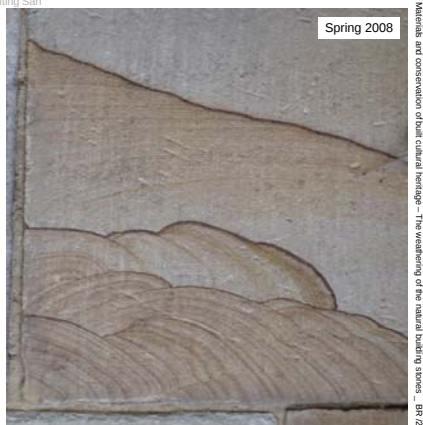
### Discolouration

Epinal Basilica (France) sandstone

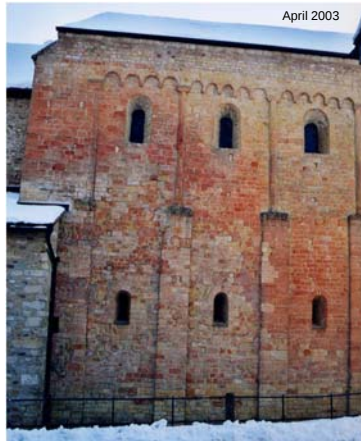
### Red staining

Abbey church  
Romainmôtier (CH, VD)  
Pierre jaune  
from Neuchâtel

- Chromatic alteration due to **local** oxidation of iron components on the stone surface often caused by a **fire**.
- This phenomenon **does not depend on weather exposure conditions**.

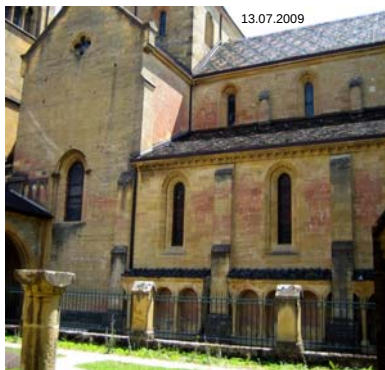
### Red staining

Collegiate church  
Neuchâtel(CH, NE)  
Pierre jaune  
from Neuchâtel

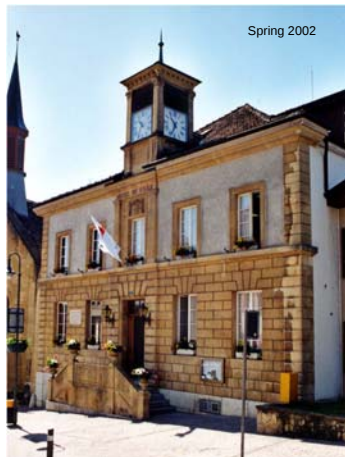
### Patina

City hall  
Boudry (CH, NE)  
Pierre jaune  
from Neuchâtel

- Black, brown, ocher, yellow
- Natural modifications of the building stones surface = normal "ageing" in outdoor environment
- Quite uniform very thin layer which sticks to the substrate from which it is chemically different (enriched in iron/clay minerals and/or in biogenetic calcium oxalates). Origin of the patina materials: endogenous (calcite, salts) and exogenous (soots, dust, micro-organisms, salts)
- Physical and colour modification but do not lead to a deterioration
- Can gradually evolve to the formation of crusts
- Usually take place in the zones protected from water supplies

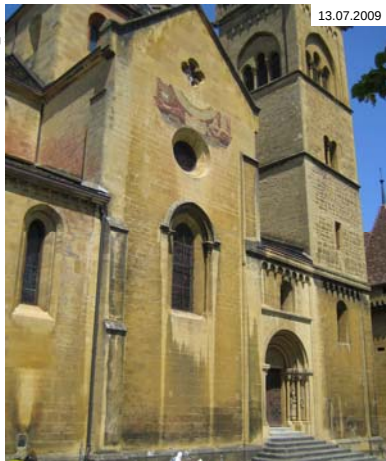
### Patina

Collegiate church  
Neuchâtel (CH, NE)  
Pierre jaune  
from Neuchâtel

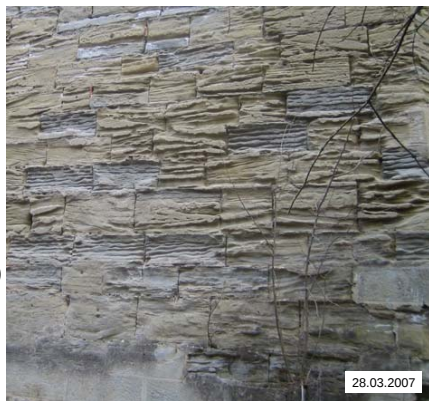
### Differential erosion

A city wall of Fribourg (CH, FR) Burdigalian Molasse sandstone

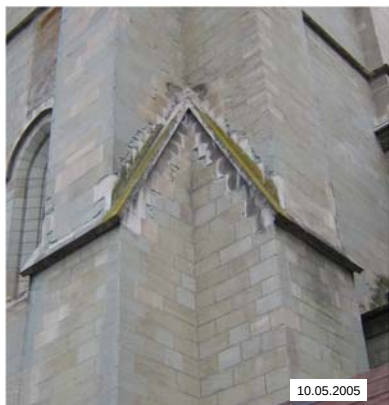
### Differential erosion

Bell tower, south side, Lausanne cathedral (CH, VD) burdigalian molasse sandstone

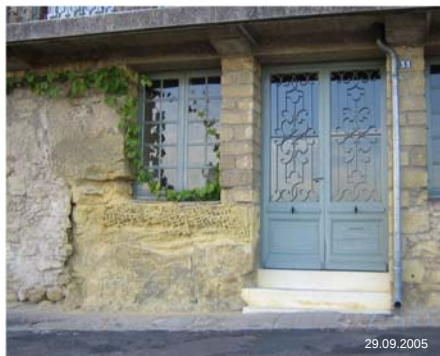
### Alveolization

Chinon  
(France,  
Loire Valley)  
Tuffeau stone

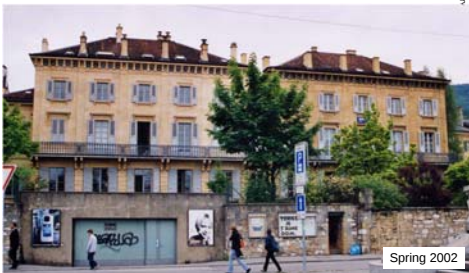
### Anthropogen erosion

Neuchâtel  
(CH, NE)  
Pierre jaune  
from Neuchâtel

- More or less harmful erosion provoked by cleanings
- According to the chosen process of cleaning, erosion will be mechanical and/or chemical
- Does not strictly depend on the exposure conditions.

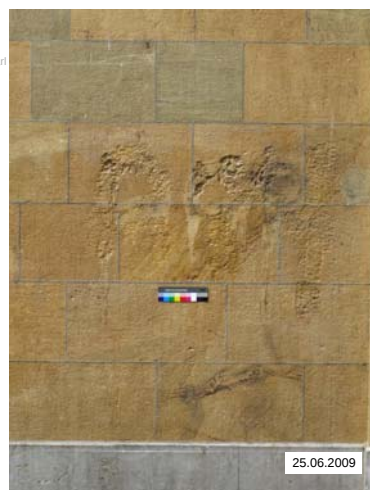
### Anthropogen erosion

Neuchâtel  
(CH, NE)  
Pierre jaune  
from Neuchâtel

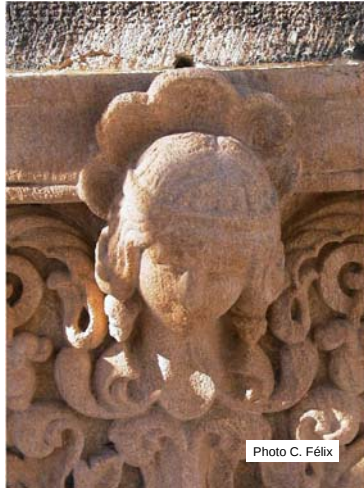
### Anthropogen erosion

Natural History  
Museum of  
Neuchâtel (CH, NE)  
Pierre jaune of  
Neuchâtel

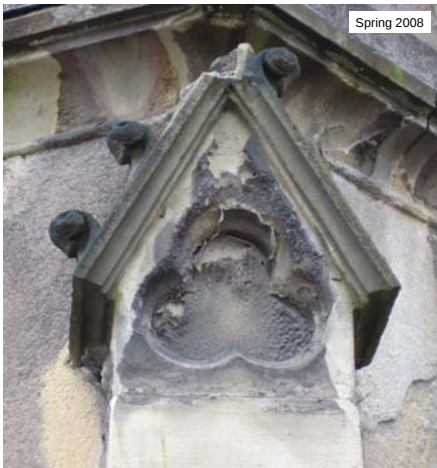
#### Crust

Epinal Basilica  
(France)  
Sandstone

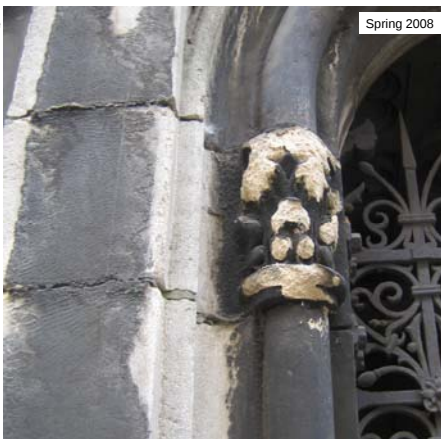
#### Crust

(Nancy, France)  
Savonnières  
limestone

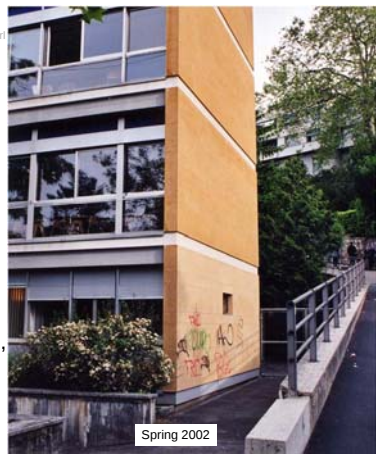
#### Film (antigraffiti)

D. de Rougemont Lycée,  
Neuchâtel (CH, NE)  
Jaumont limestone

- Very thin covering or coating layer, usually homogeneous and of organic nature
- More or less easy to remove it from the substrate
- Does not strictly depend on the exposure conditions to water supplies.

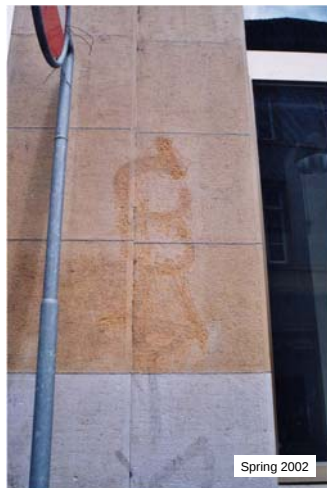
#### Film (antigraffiti)

Neuchâtel (CH, NE)  
Pierre jaune  
from Neuchâtel

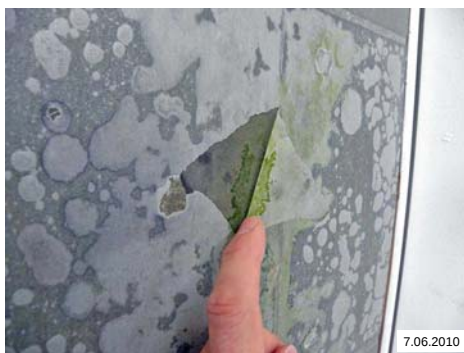
#### Film (antigraffiti)

Geneva  
(CH, GE)  
(photo O.  
Fawer)

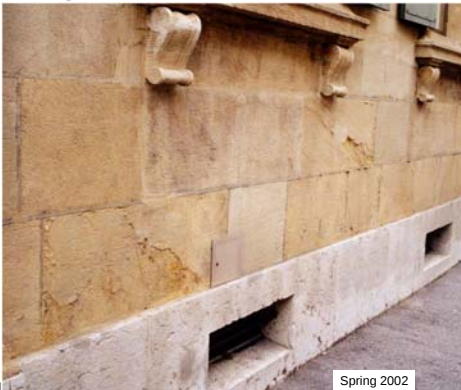
#### Film (antigraffiti)

Neuchâtel  
(CH, NE)  
Pierre jaune  
from Neuchâtel

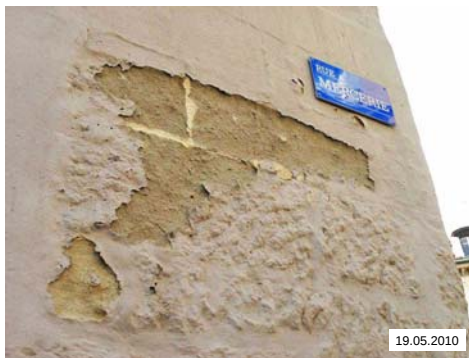
#### Film (paint layer)

Lausanne  
(CH, VD)  
(photo O.  
Fawer)

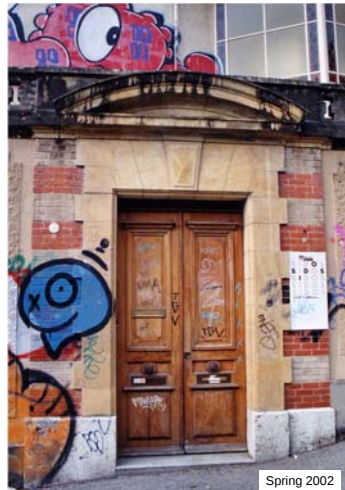
#### Graffiti

Ruelle Vaucher  
Neuchâtel (CH, NE)  
Pierre jaune from  
Neuchâtel, bricks &  
rendering (*crépi*)

- Results from the engraving, scratching or application of paint, ink or similar matter on the stone surface
- This phenomenon **does not depend on the exposure conditions to water supplies.**

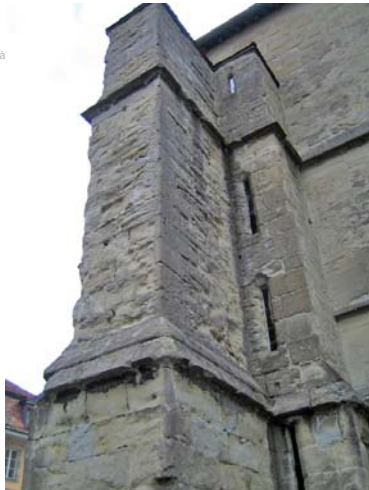
### Granular disintegration

Bell tower, west  
Lausanne Cathedral  
(CH, VD)  
Aquitanian molasse  
sandstone

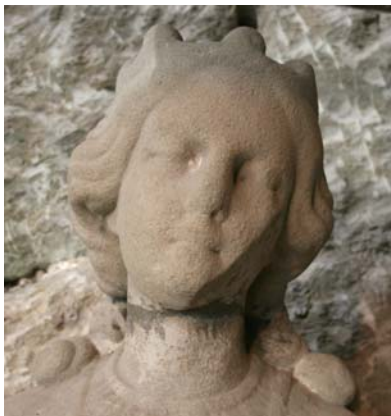
### Granular disintegration

Musée d'Art et  
d'Histoire  
Fribourg (CH, FR)  
Statue from the south  
cathedral portal  
Burdigalian molasse  
sandstone

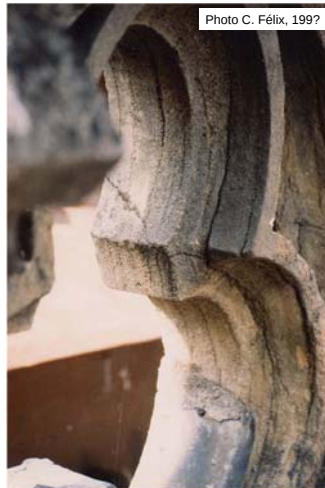
### Delamination

Salle du Grand Conseil,  
Neuchâtel (CH, NE)  
Pierre jaune from  
Neuchâtel

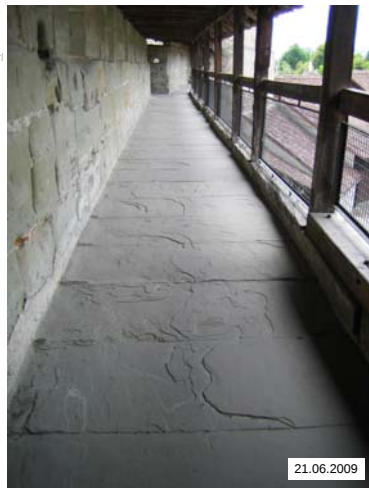
### Delamination

Morat (CH, FR)  
walkway on the  
city wall  
Burdigalian molasse  
sandstone

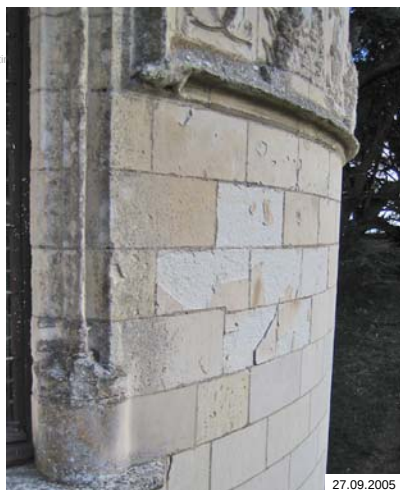
Scaling

Chaumont castle  
France, Loire Valley  
Tuffeau stone

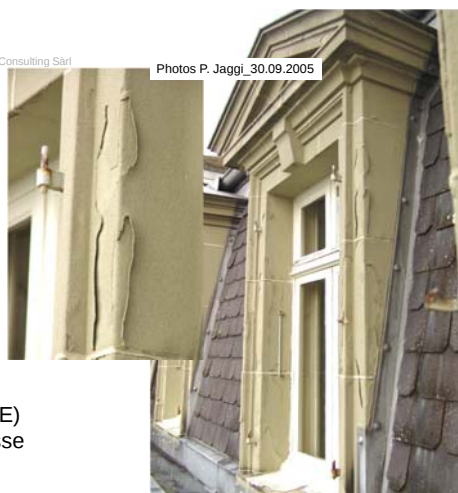
Scaling  
(because of  
water  
repellent)

Rue de l'Evoile  
Neuchâtel (CH, NE)  
Burdigalian molasse  
sandstone

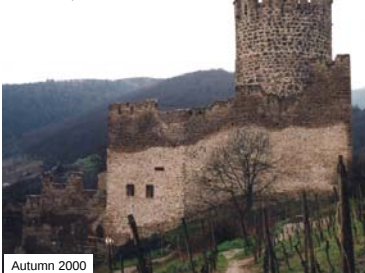
### 5a - Water supplies Rising damp?

Kaysersberg castel,  
France, Haut Rhin

- Caused by water absorption by capillarity from the ground at the base of walls or from a surface of retention
- Moisture goes through the walls, wets the internal and external surfaces where a horizontally limited stain is visible
- Takes place in zones where water supplies from the wall bases (or from a surface of retention) are important.

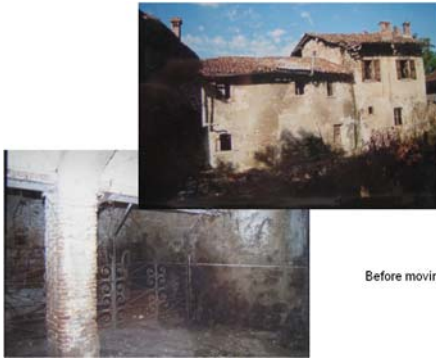
### Damp patches

Ballenberg museum (CH, BE)  
(farmhouse from Tessin)

- The material surface shows wet spots or zones of different color, generally darker
- Can be caused for example by the penetration of water (by rising damp) and/or by the hygroscopic behaviour of salt.

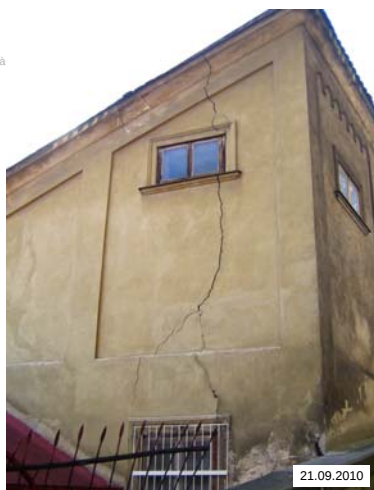
#### Crack, fracture (static)

Prague (Czech Republic)
